# Cracked tooth diagnosis and treatment: An alternative paradigm

John S. Mamoun<sup>1</sup>, Donato Napoletano<sup>2</sup>

## ABSTRACT

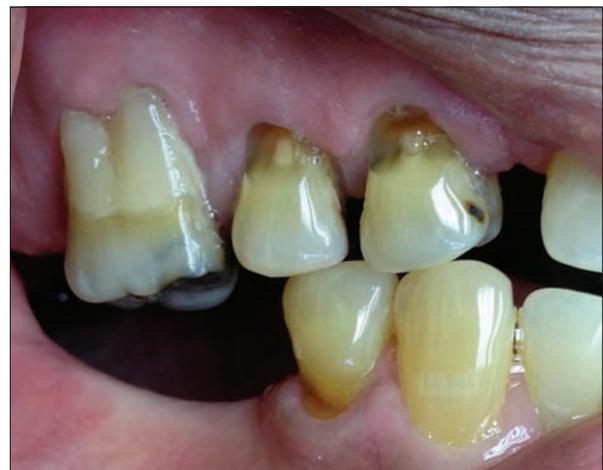
**Figure 1:** A lateral view of two premolars that experience heavy occlusal forces due to lack of molar occlusion, which also have abfraction lesions

protruding maxillary molar palatal cusps<sup>[12]</sup> occluding powerfully into the mandibular molar central grooves. Maxillary premolars, which often have steep inclines on nonfunctional cusps that result in torque forces during mastication, are more likely to crack than mandibular premolars, which experience mostly compression forces due to opposing teeth occluding into the mandibular premolar buccal cusps. A posterior tooth with a class II restoration may be the source of discomfort if it is the only remaining (or restored) posterior tooth in that quadrant, or if it shows signs of occlusal trauma or an abfraction lesion [Figures 1 and 2].

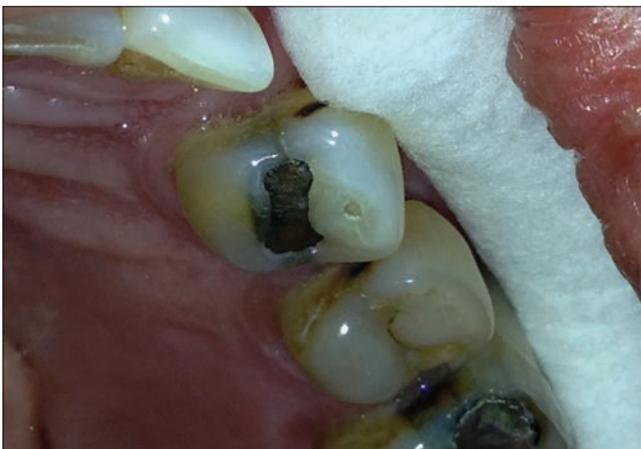
**Figure 2:** An occlusal view of the premolars from Figure 2 also shows marginal ridge fractures

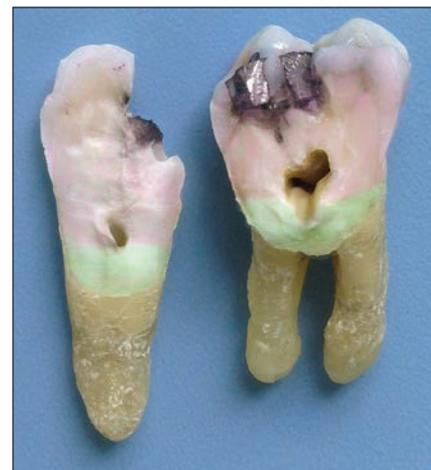
**Figure 3:** The palatal root (left) disconnected from the buccal roots (right) of this maxillary molar via a furcation fracture. Here, a stress plane superior to the pulp chamber floor (pink) and another stress plane between the pulp chamber floor and the external tooth surface between the roots (green) both fractured, resulting in complete palatal root disconnection

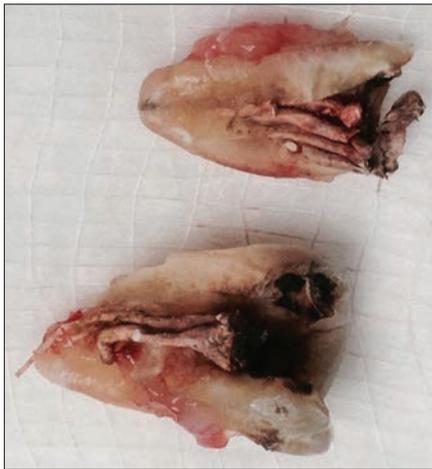
**Figure 4:** Hypothetically, the furcation fracture in this mandibular molar may have resulted partially from gutta-percha filling much of the pulp chamber, and increasing the flexibility of the pulp chamber walls and floor, compared to if the chamber was filled with a stiff core material

lingual aspects, and also binds the buccal aspects of the tooth structure that is occlusal and apical to the pulp chamber, respectively, with the lingual aspects. Any posterior tooth restorative preparation that involves removal of the mesial or distal marginal ridges (such as class II preparations), or the tooth structure occlusal to the pulp chamber roof (such as endodontic access openings<sup>[21-23]</sup> or deep class I preparations),<sup>[24,25]</sup> results in less tooth structure remaining to resist split-apart stresses.<sup>[26-34]</sup> Leaving too much soft gutta percha inside a pulp chamber after making a post/core or core build up, instead of filling the entire chamber with a strong core material, may increase the overall flexibility of a molar or premolar tooth, and the long-term rate of furcation fracture plane expansion [Figure 4].<sup>[35]</sup>

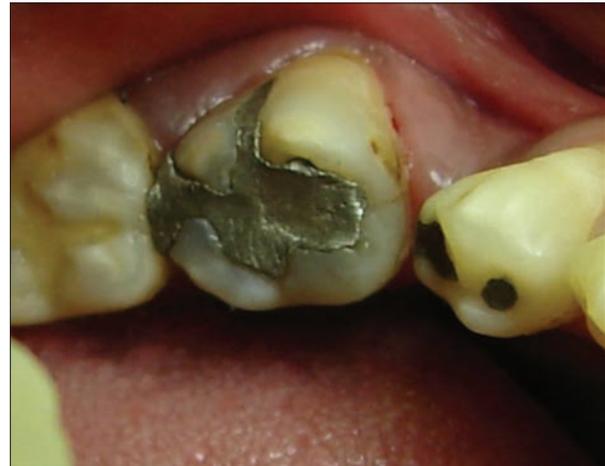
**Figure 5:** A molar with a class II restoration and a crack in the untouched marginal ridge

cracks [Figure 5]. Furthermore, if a tooth with a class II restoration is sensitive, a dentist may remove the restoration to observe if a crack line exists underneath the restoration [Figures 6 and 7]. If no crack line is observed, the dentist (conservatively) replaces the restoration. However, an observed crack line may be interpreted as a partial fracture of a furcation stress plane that is presumed to exist in that tooth, where the tooth has a missing marginal ridge on one side (due to the restoration), and a compromised marginal ridge on the other side (due to the crack). Here, a crown and possibly endodontic treatment may be needed.

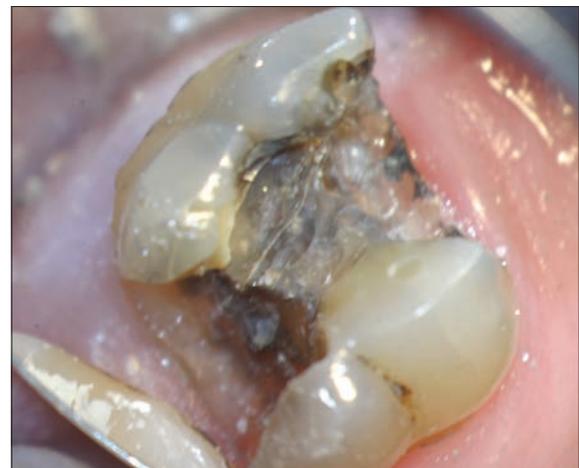
**Figure 7:** Removal of the amalgam reveals the crack lines of a cuspal fracture plane along the apical-axial aspect of the buccal cusps and a partially fractured furcation stress plane

Cuspal fractures can be caused by forces put on existing restorations during masticatory cycles; these forces stress the stress planes located apical to the cusps that retain the restorations.<sup>[32,40]</sup> With an amalgam, the preparation axial walls converge toward the occlusal, so occlusally directed forces on the restoration stress the cuspal stress planes. The walls of an inlay preparation diverge toward the occlusal, so apically directed forces stress the cuspal stress planes. If the dentist removes the restoration and observes the dried preparation surface, the dentist may observe a crack line located at what was previously the apical-lateral aspect of the restoration [Figure 7].

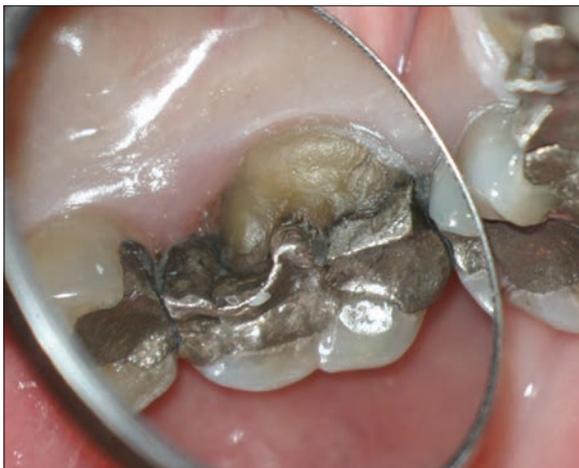
**Figure 8:** A complete fracture of a molar lingual cusp shows a void that is bounded axially by a large mesial-occlusal-distal amalgam that the cusp was helping to retain

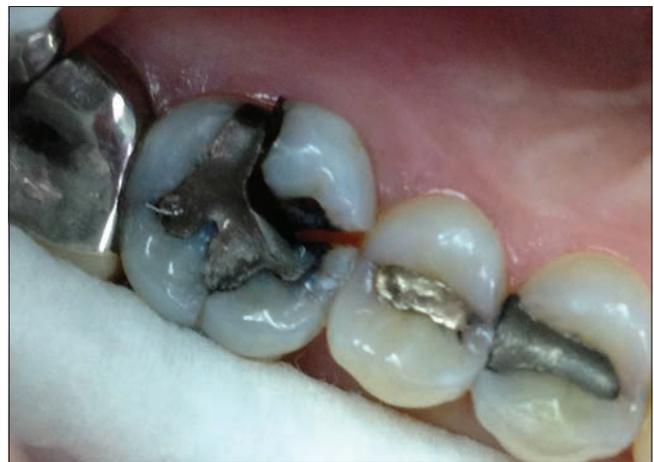
**Figure 9:** A complete fracture of the mesial-lingual cusp of a maxillary molar, retained only by gingival tissue

A cusp may fracture off the tooth but be retained by gingival tissue [Figure 9]. When the patient occludes, the cracked piece may jab the gingiva but only cause soft tissue pain. Removing the loose piece may indefinitely relieve sensitivity, and with polishing the tooth may be indefinitely stable, without requiring further restoration. When restoring the tooth with a direct restoration, microscopes facilitate observing that an opposing pointy plunger cusp does not occlude into the restoration isthmus.

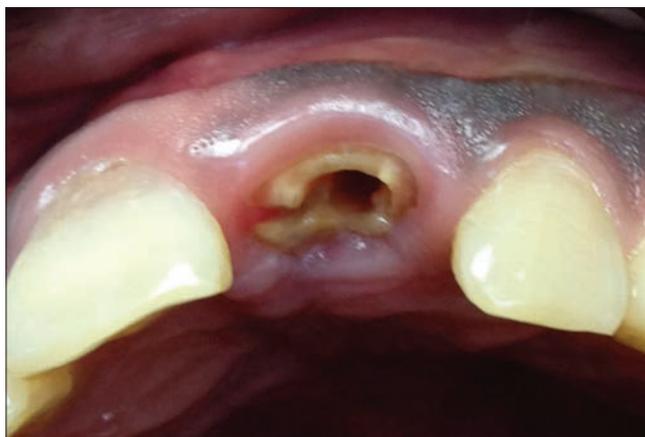
**Figure 10:** A maxillary central incisor showing a root fracture and a gingival interface fracture, due to a post and core that fractured the root due to lack of ferrule tooth structure

A root fracture is a fracture of a stress plane contained within only one root, such that complete fracture of the stress plane would not result in disconnection of one root from another [Figure 10]. Root fractures,<sup>[3,48]</sup> which are often catastrophic fractures,<sup>[49]</sup> can result from caries in root structure or from roots containing intra-canal retainers<sup>[2,50]</sup> where the tooth lacks ferrule tooth structure, which results in a post putting more stress on the root.<sup>[51,52]</sup> Roots can also be fractured via use of excessive pressure while obturating root canals;<sup>[53-56]</sup> using excessive vertical forces to push a peeso reamer into a root while making a postspace, particularly if the peeso reamer is too wide in diameter compared to the diameter of the canal; skipping sizes of peeso reamers while making a postspace, such as moving from a #1 peeso reamer directly to a #3 peeso reamer, particularly when preparing postspaces in thin roots, which are common with premolars or mandibular incisors; or radicular micro-cracks<sup>[45,57]</sup> created during apico-ectomy procedures using ultrasonic retro-tips. One study<sup>[53]</sup> showed that the

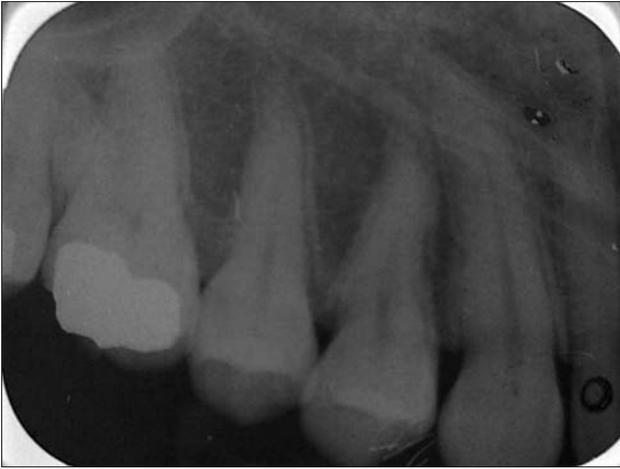
**Figure 11:** A radiograph of a maxillary molar that contains minimal remaining coronal tooth structure that can help to retain the large mesial-occlusal-distal restoration. The remaining tooth structure is under higher stress levels from retaining the restoration. Part of the distal aspect of the remaining tooth structure fractured, showing that the remaining tooth structure is not strong enough to retain this direct restoration without developing cracks

that is deep in an occlusal-to-apical direction [Figure 11], where there is minimal height of tooth structure from the gingival interface level of the tooth to the apical level of the restoration. A crown and possibly a post may be needed to retain the supra-gingival restoration. However, if the restoration has a buccal or lingual component that reaches the CEJ area of the tooth, then the restoration, on the radiograph, may appear deeper than it is in reality.

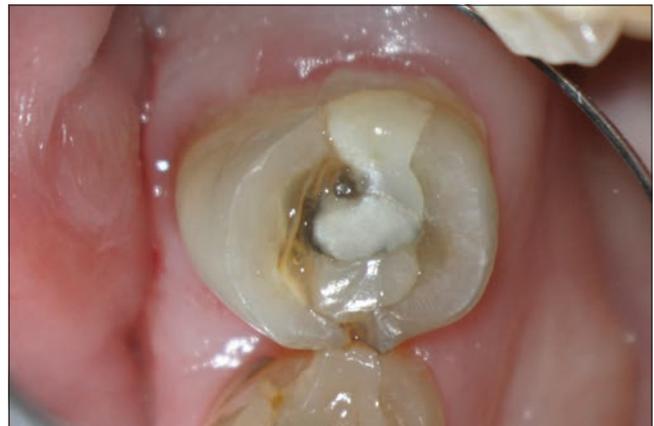
**Figure 12:** A sensitive premolar shows a cleft and a microscopically thin crack line, with a minimal color contrast with surrounding tooth structure

Microscopes facilitate observation of microscopic crack lines that may show minimal color contrasts against a desiccated tooth surface [Figure 12], without needing trans-illumination or dyes to observe crack lines. Microscopically precise tactile sensation permits verification of a crack by associating the tactile sensation of an explorer tip falling into a cleft with the microscopic point on a crack line where the tip is located. Microscopes permit detecting microscopic

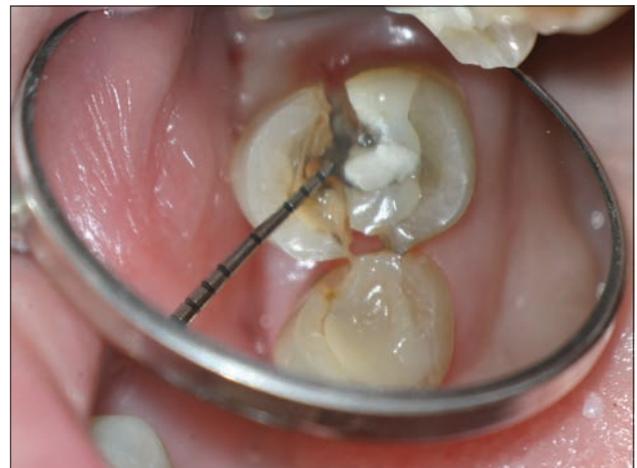
**Figure 13:** A periodontal probe in the premolar separates the cracked piece
